Weathering the storm: A framework to assess the resistance of earthen structures to water damage

This paper presents a framework for assessing the durability of earthen materials based on perceived routes of exposure to water. The framework is built upon the findings of a review of nearly 60 articles discussing original durability testing programmes, comprising 118 investigations and almost 700 soil and stabiliser combinations. From these works, 12 assessment methodologies were

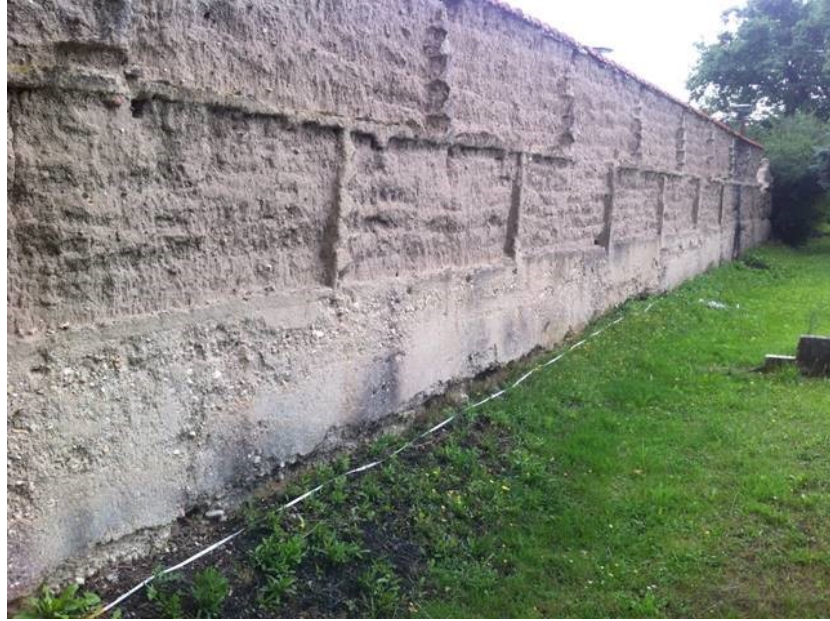
Figure 2: Damage (loss of surface material) to a pisé wall in Précieux in the Loire Department, France, due to exposure to direct rainfall. Photograph: Nicolas Meunier
